Lime Kiln ID Fan Upgrade Project

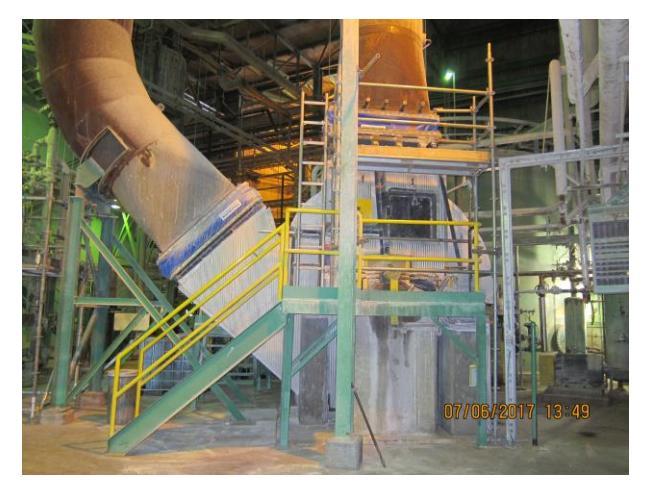
AirStream reached out to an Alberta mill outlining a customized solution to the problem of dust build-up on their Kiln ID Fan in early 2017. The hardened dust deposit required sandblast cleaning every 3-4 months because it caused excessive vibration.

Fig.1 Existing fan housing and original rotor subject to vibration caused by hard build up

Later that year following the onsite collection of data, AirStream identified aerodynamic issues that were resulting in dust build-up and offered a solution in the form of a fan rotor upgrade. The proposal included a new high-efficiency fan rotor with an increased capacity of 55,000 cfm with 38.31 "WG static pressure rise.

Furthermore, the existing motor, bearings, coupling, and fan housing were found to be suitable for reuse without any modifications. AirStream proposed new carbon ring shaft seals to minimize dust leakage onto the bearings.

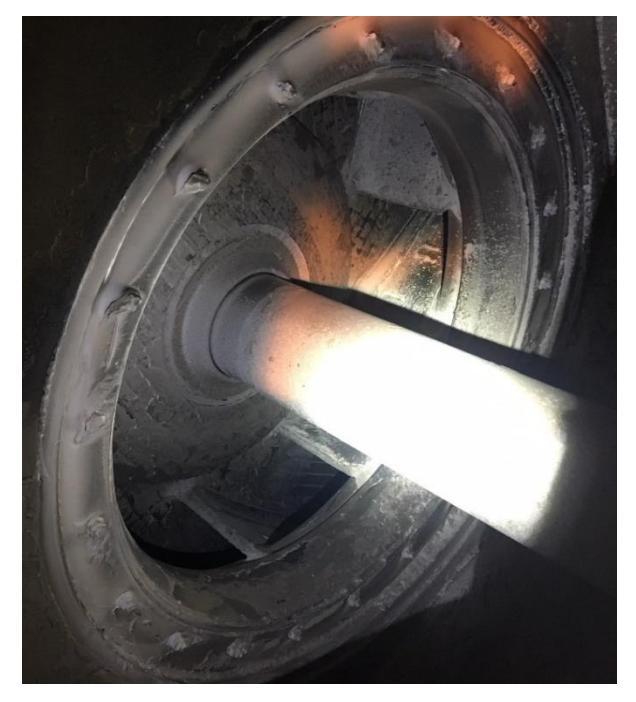
Fig.2 AirStream fan after 8 months of continuous operation

After 8 months of continuous operation, site personnel confirmed acceptable low levels of vibration without the need for unscheduled cleaning maintenance shutdowns. Following the first scheduled outage, AirStream projections of uninterrupted fan operation, for 12 months, were verified by mill operators.

In September 2017, the turnkey project was ordered, and AirStream fabricated and installed an upgrade rotor tailored to the specific mill conditions.
