Lime Kiln ID Fan Upgrade Project

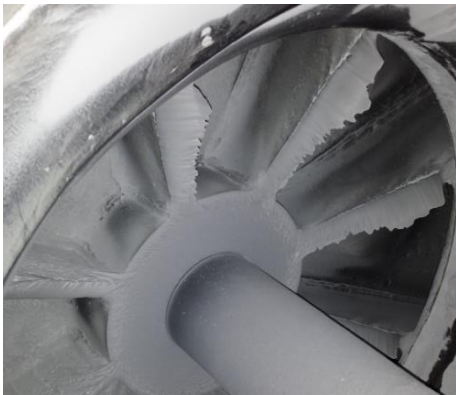
In 2014, AirStream contacted an East Coast pulp mill presenting a unique approach to evaluating problems with dust build-up on the mill's No.1 and No.2 Lime Kiln ID Fans. Due to high vibration caused by scaly build-up, the fans were being cleaned every few weeks. During the evaluation process, both fans were identified to be operating at low efficiency, primarily due to the radial blade design. While offering intrinsically lower efficiencies, radial bladed fans are often selected for use in dusty applications because they are thought to minimize build-up.

Fig.1 The original fan rotor required sandblasting every 2-3 weeks to remove hard build-up.

This data gathering process enabled AirStream to propose supply and installation of a new high-efficiency fan rotor capable of delivering 50,000 cfm with 29.69" WG static pressure rise. The existing fan housing, bearings, motor and coupling were confirmed to be suitable for reuse, while AirStream supplied new carbon ring shaft seals to minimize dust leakage onto the bearings. No modification of the fan housing was required.

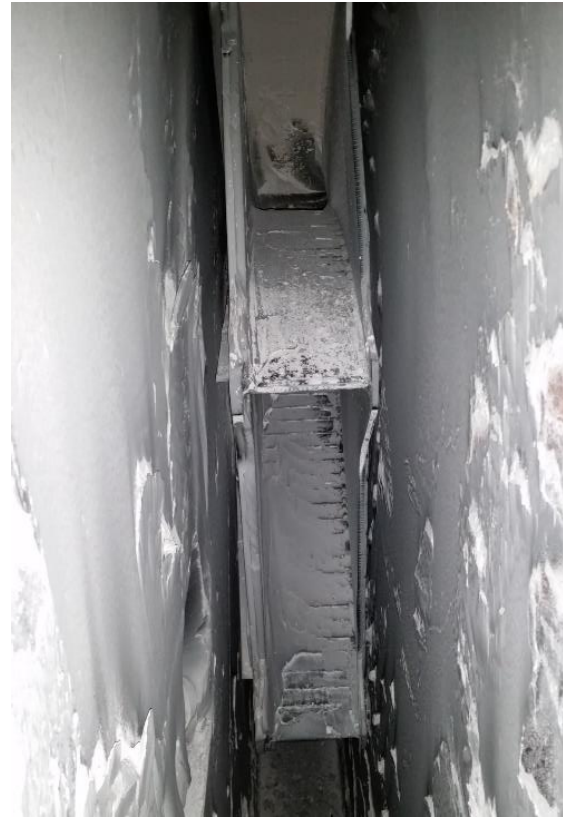
Fig.2 The high-efficiency AirStream rotor can operate continuously for 1 year without requiring cleaning..

The turnkey project was ordered, and the new fan was installed by AirStream in March 2016. After 1 year of continuous operation, site personnel reported that the fan had not been required to shut down for cleaning since installation. The hard build up had been eliminated and 43 kW in VFD input power savings were reported. The verified results of the fan upgrade are outlined below. The mill engaged AirStream to supply the upgrade for the No.2 Lime Kiln ID Fan in early 2020.

Operating Parameter	Original Rotor	AirStream Rotor
Operating Condition Power	223 kW	179 kW
Design Condition Power	268 kW	224 kW
Cleaning Frequency	Every 2-3 weeks	Annually
Build-up Description	Hard, scaly, cleaning required sand blasting	Soft, easily washed off
